Southeast Tornado MAT

Daily Report

Tuesday 10MAY2011

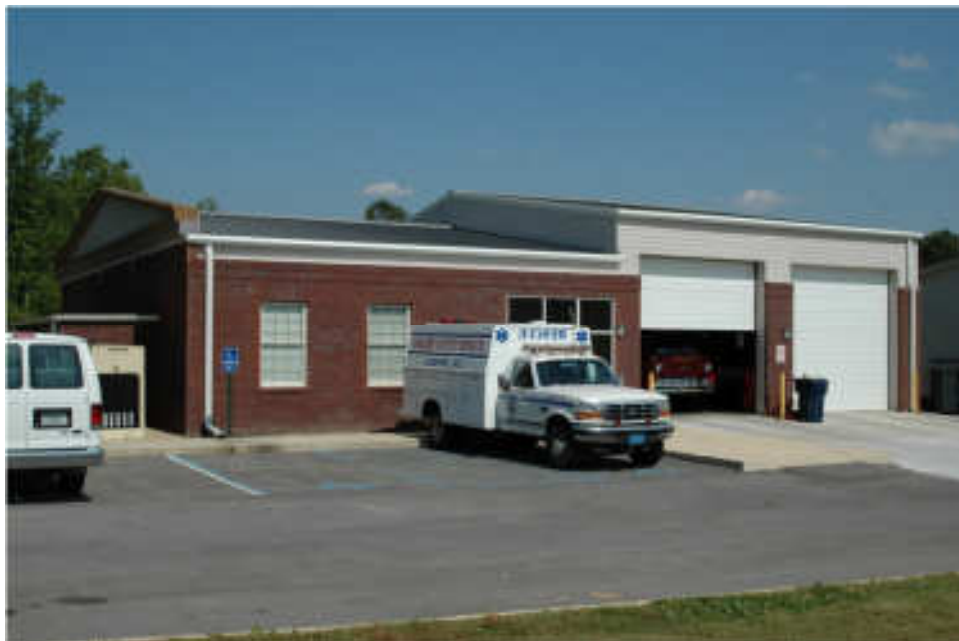
Brookside Alabama has a new community storm shelter constructed after a flood loss of their existing Fire Station. It is a FEMA 361 community shelter built in 2009 with a FEMA grant. The facility has a capacity for 300 (33'x50') and had 150 occupants during this event. There was no visible damage from this storm. The Mayor thinks even more will go in next time. The city staff was very appreciative of their newly constructed tornado shelter.

Brookside, AL: Fire station on top of community shelter.

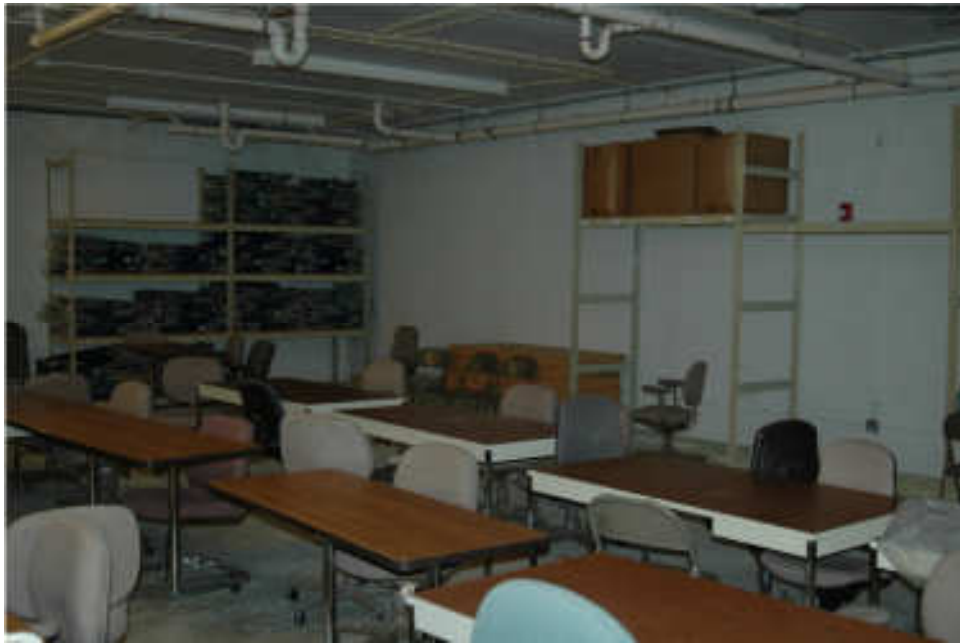
Brookside, AL: Inside of Community tornado shelter

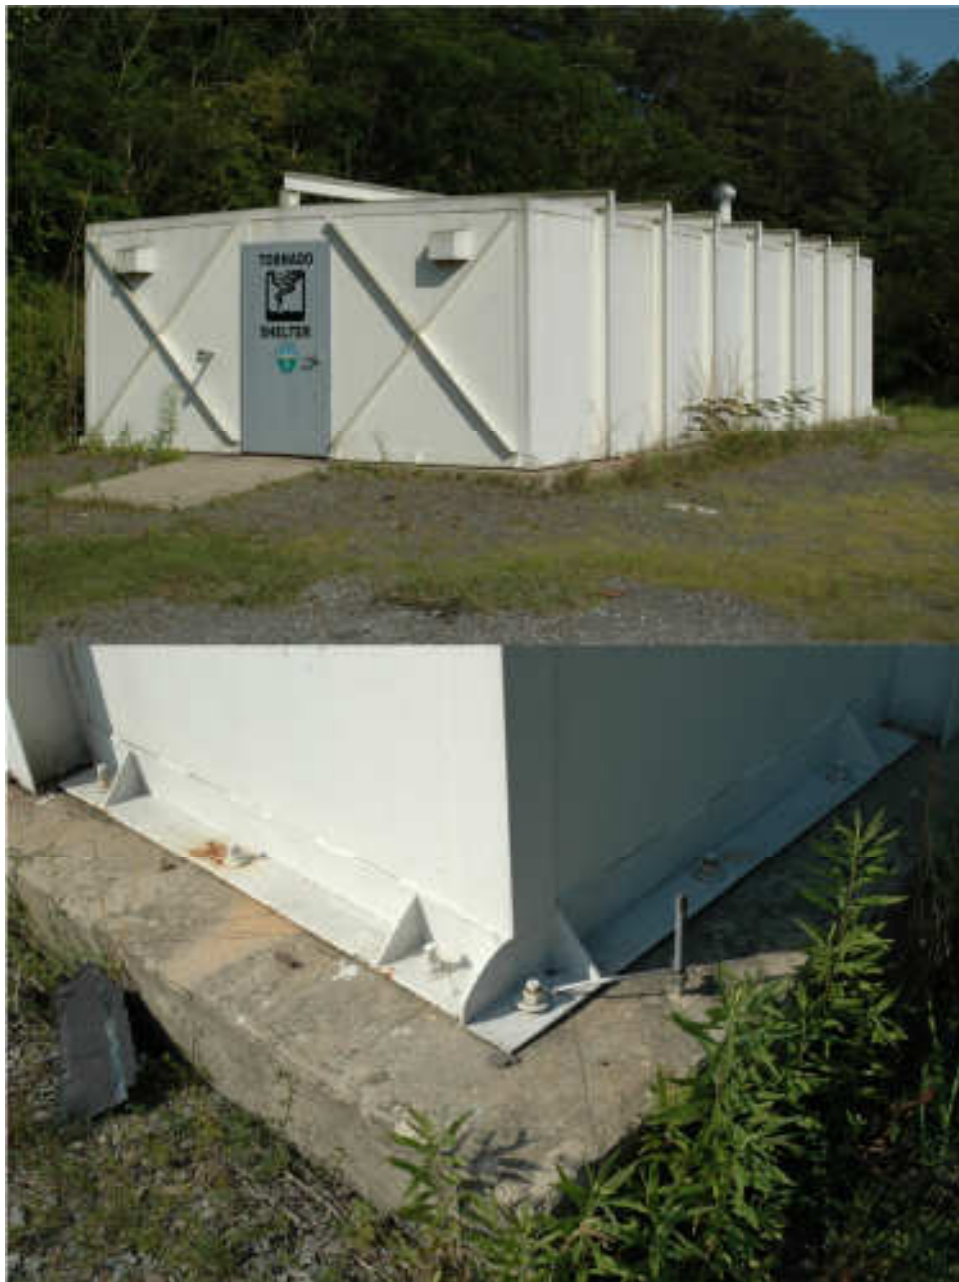
Graysville has an above ground Tornado Shelter. It is constructed from $\frac{1}{4}$ steel plate and is well anchored with $\frac{3}{4}$ " diameter bolts at 18" on center. Other than egress it appears FEMA 361 compliant.

Graysville, AL : Above ground Tornado Shelter

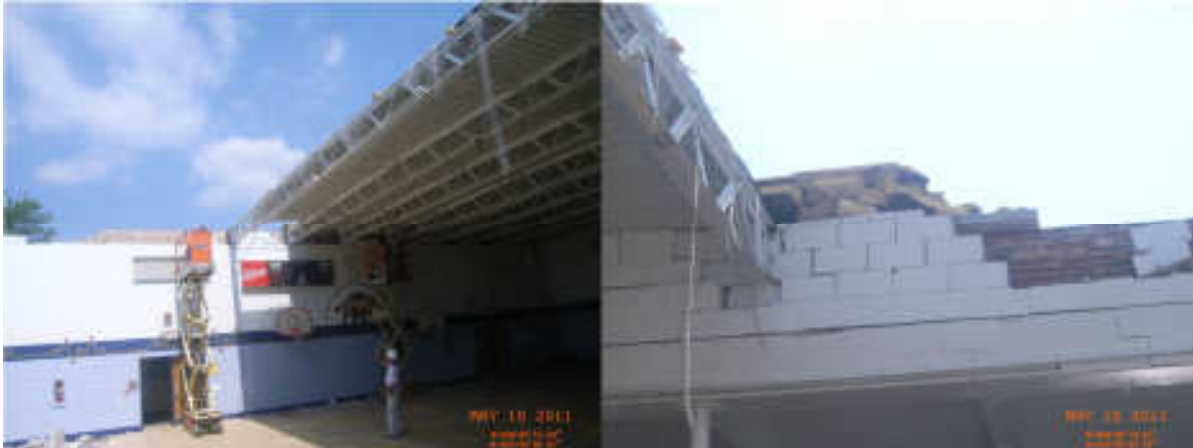
Cleveland TN: This elementary school on Michigan Ave had severe structural damage

- Location: Michigan Avenue Elementary School
- Left photograph shows the gymnasium of the school, reportedly built in the 1950s. Approximately 1/3 of the roof system was found 20+ feet from the gym. The right photograph shows steel bar joists which spanned approximately 45 feet and were supported by partially grouted CMU. Team 2 observed damaged glazing to a large window (approximately 40 sq.ft.) in the same area.
- No students occupied the school during the storm.

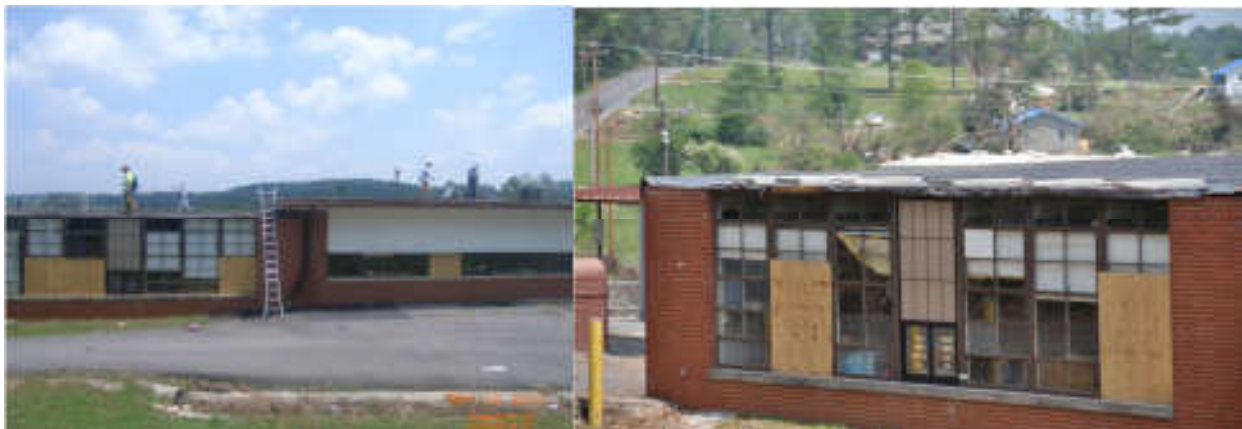
Blue Springs, TN: This elementary School had minor damage to windows but no structural damage.

- Location: Blue Springs Elementary School
- The school suffered no significant structural damage, however minor damage was observed to glazing, window frames and roofing. Rooftop HVAC equipment remained secured to roof deck and some loose roof aggregate was displaced by the storm.
- Right photograph shows plywood at broken glazing, and the concrete planks on the roof that blew off -- after the storm they added OSB where the planks blew away, repositioned the membrane, and then placed the planks over the membrane for temporary ballast.
- No students occupied the school during the storm.

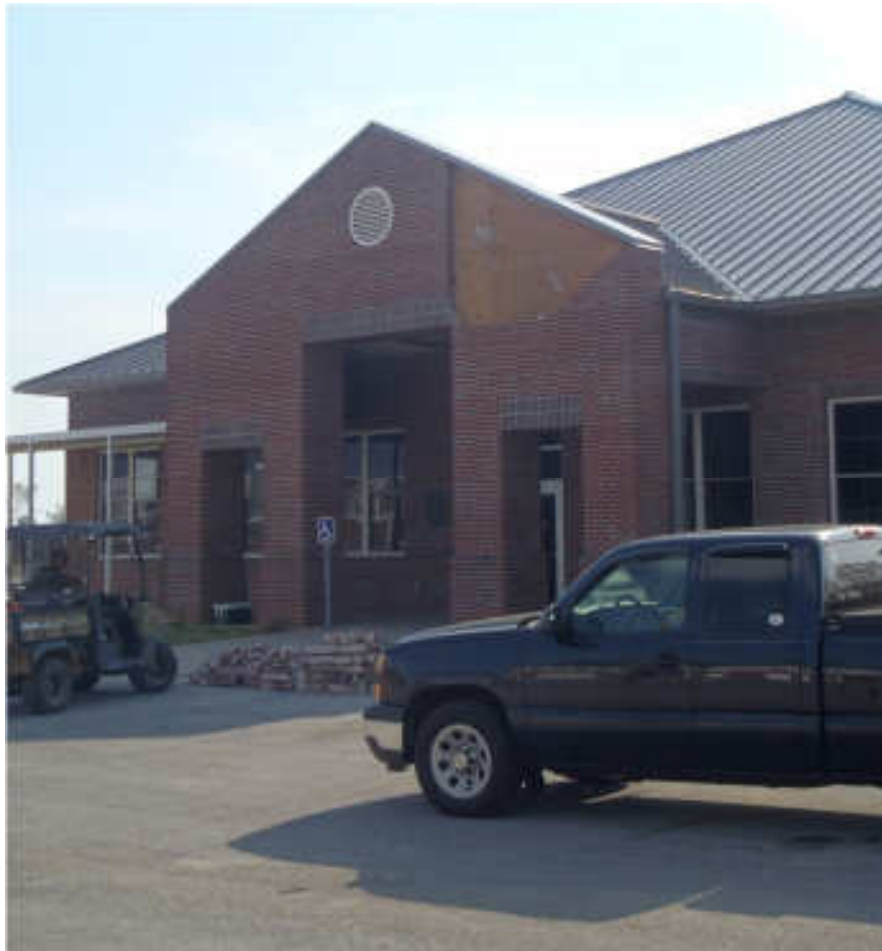
Phil Campbell, AL: High School Cafeteria had loss of façade brickwork.

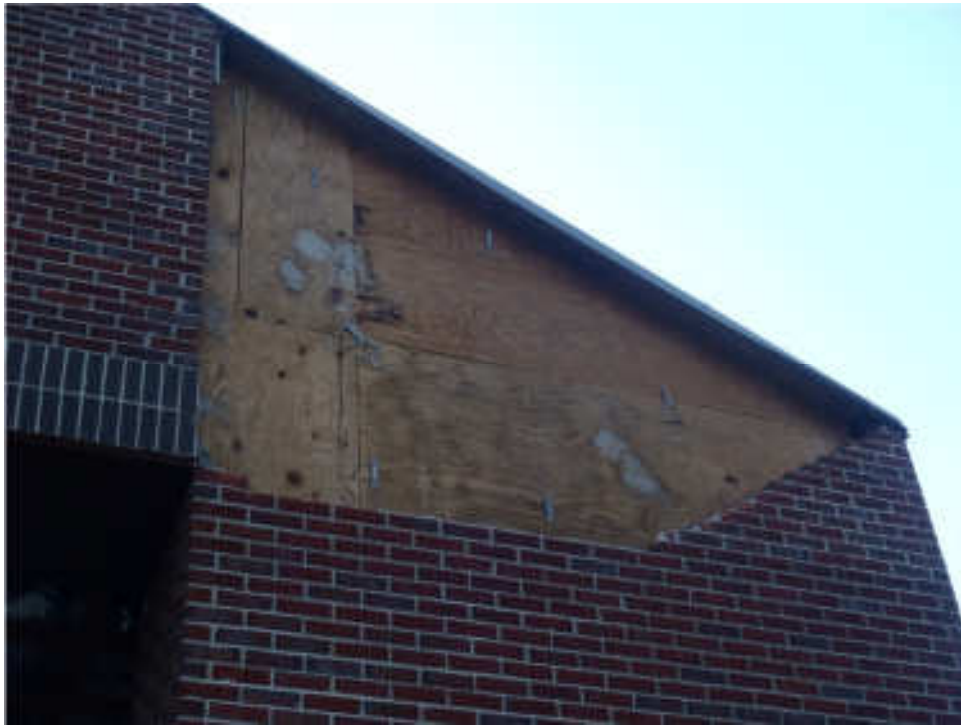
Phil Collins, AL: High School Cafeteria (close up) showing brick tie spacing.

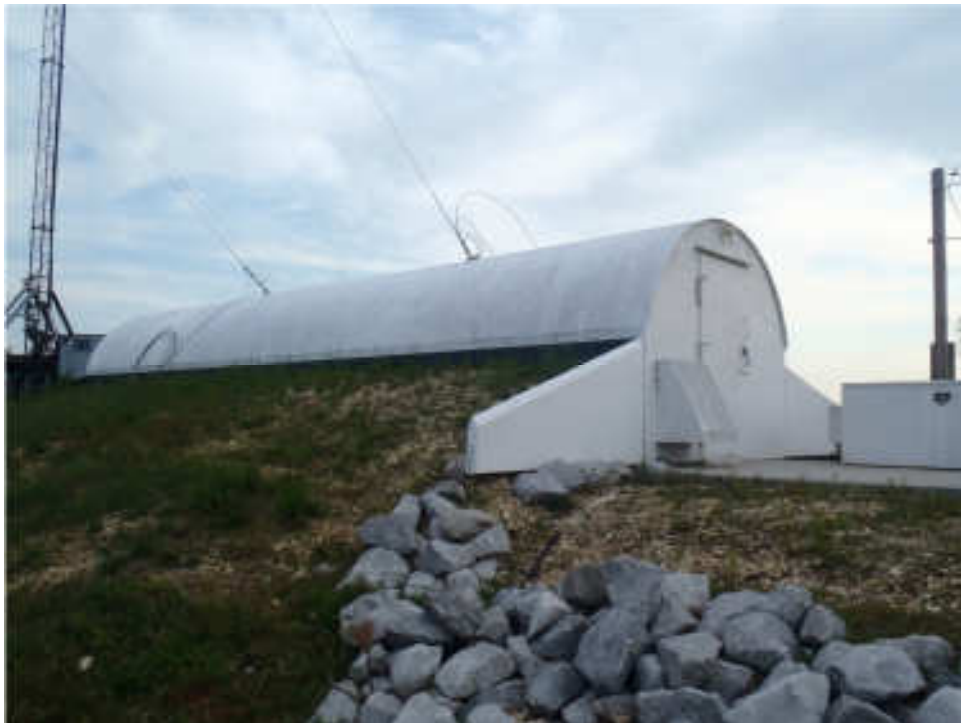
Phil Campbell, AL: Community Shelter: Held 60 people during the storm
